## Emergency railway foundation repair in Lovosice, Czech Republic

# Factsheet **Special application**

## Deep foundation

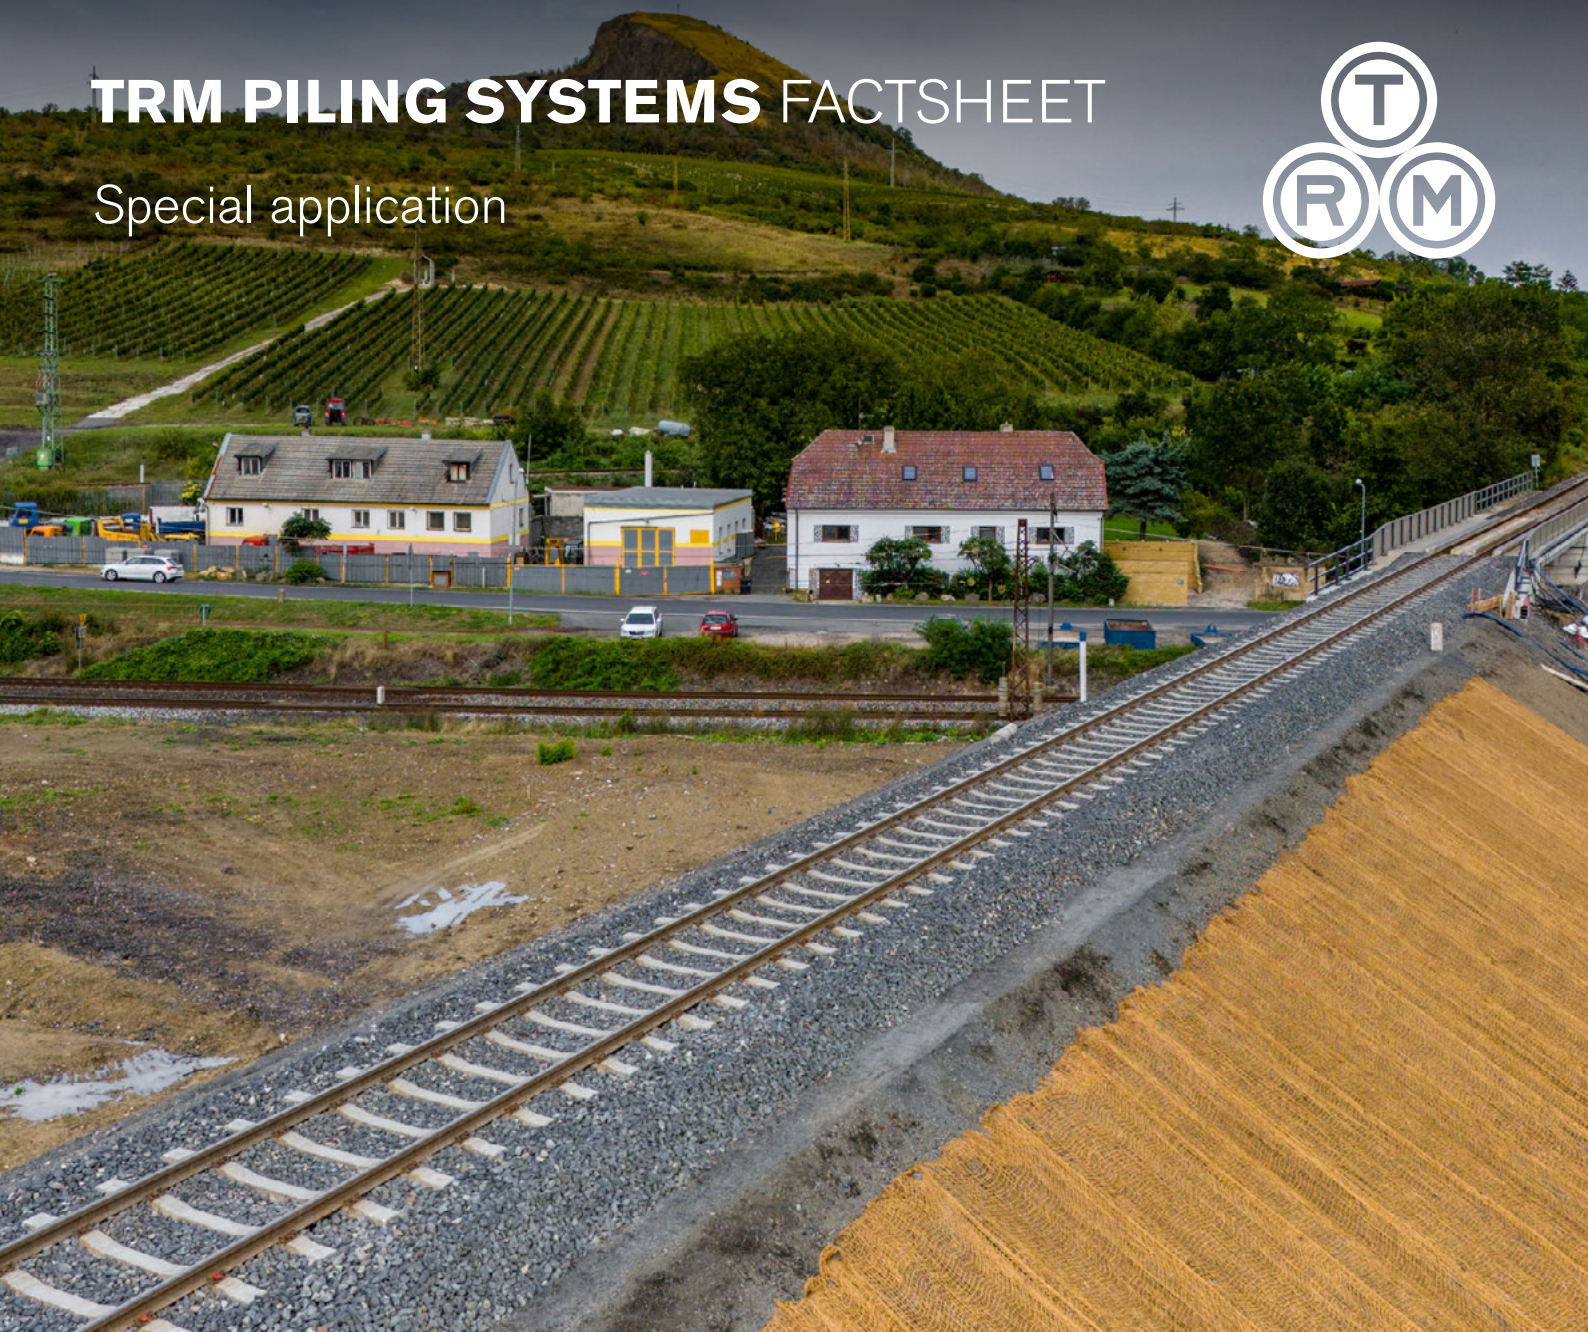
- + 22 pcs. ductile driven piles with a total meterage of 308 m
- + Pile type TRM 118/9.0 with grouted pile shoe TRM 220
- + Foundation depths up to 14 m
- + Piles needed to be delivered and installed within very short time
- + Installation time: 2 days

After extreme rainfall caused foundation issues along the Lovosice railway line in the Czech Republic, immediate stabilization of the bridge abutment and track foundation was essential. To address the challenge, **22 ductile driven piles** of type **TRM 118/9.0** with a **grouted pile shoe TRM 220** were installed to **depths of up**

**to 14 meters**. The TRM Piling System's **efficient installation** process enabled **completion within just 2 days**, highlighting its suitability for time-critical projects. The ductile iron piles delivered robust and reliable deep foundation support, **ensuring long-term stability for the railway infrastructure**.

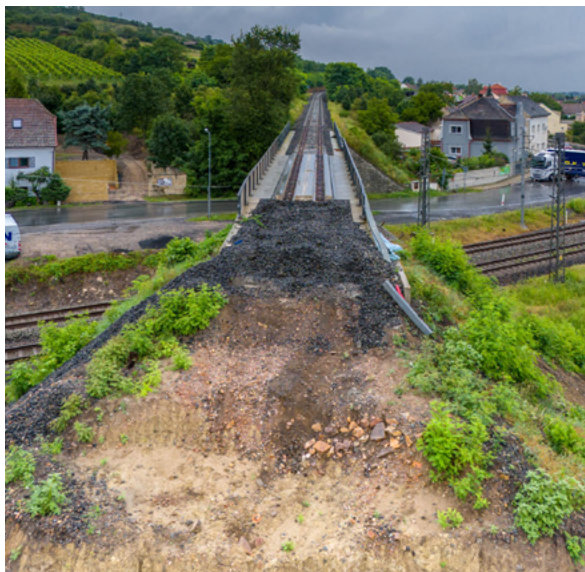
Emergency situation after heavy rainfall

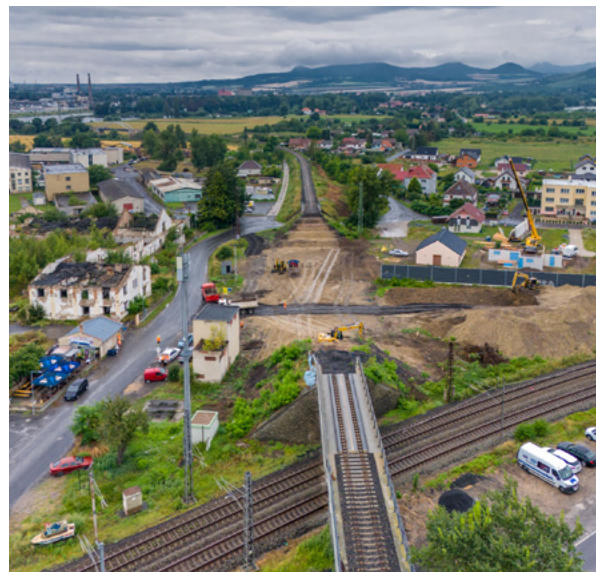
Due to heavy rainfall, the foundations of the railroad track in Lovosice (Czech Republic) could not withstand the forces of the storm.

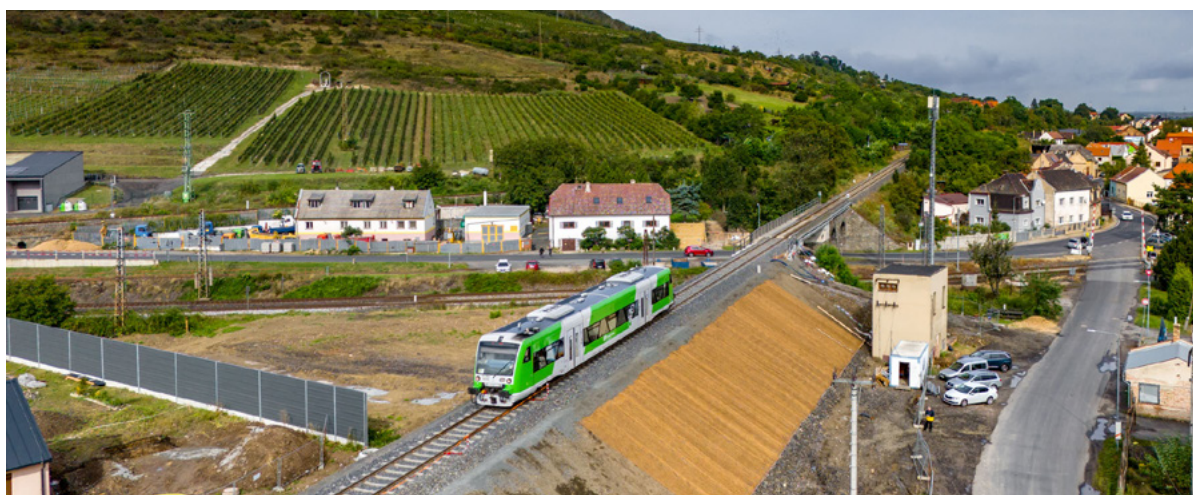
Finalized railroad founded on TRM Piling Systems

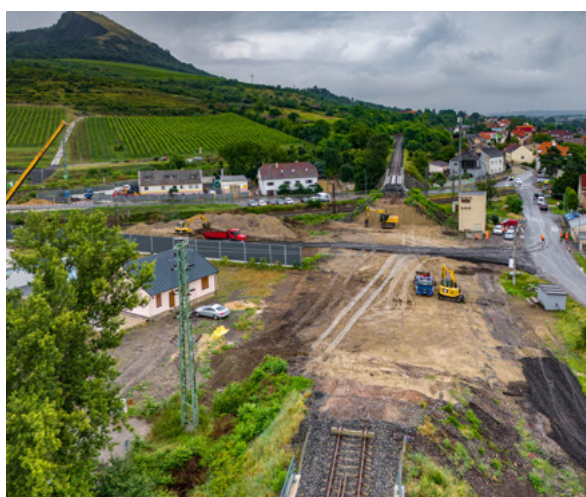
Repair work after the heavy rainfall

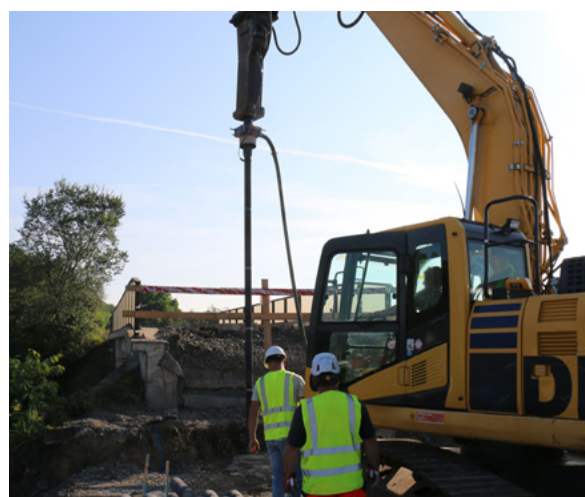
Installation of the TRM ductile driven pile
